EXECUTIVE SUMMARY

INTRODUCTION

TECHNICAL REPORT

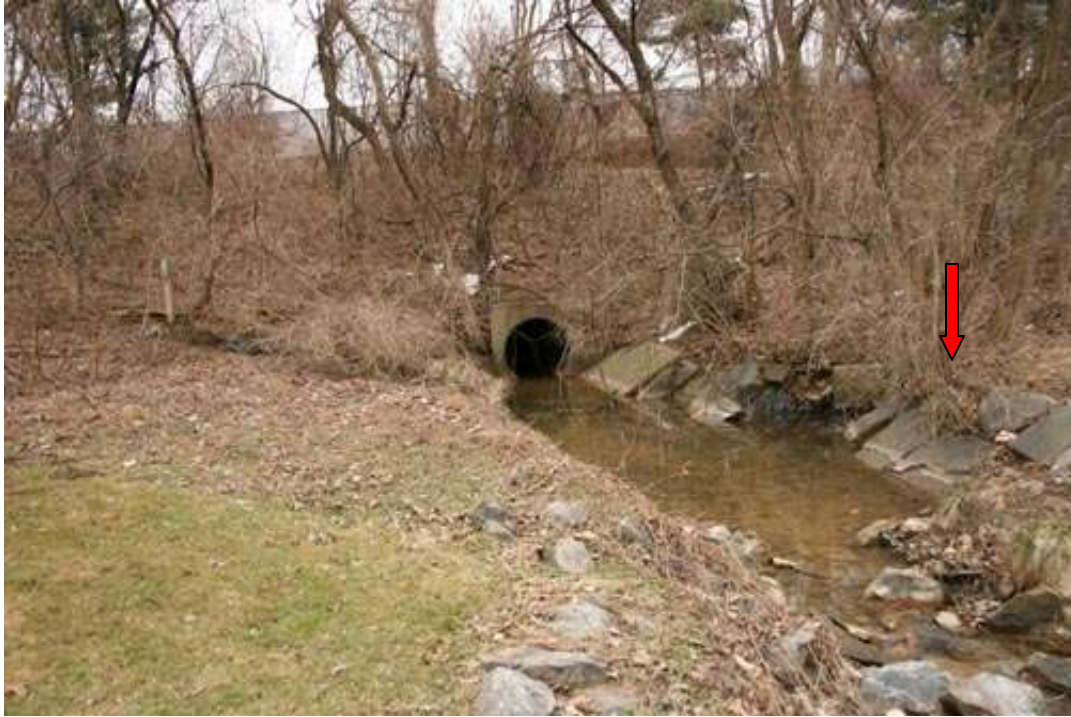
Fig. 1 (view upstream) – The 66-inch storm drain outfall at upstream end of Reach 1. Location of 24-inch storm drain outfall indicated by red arrow.

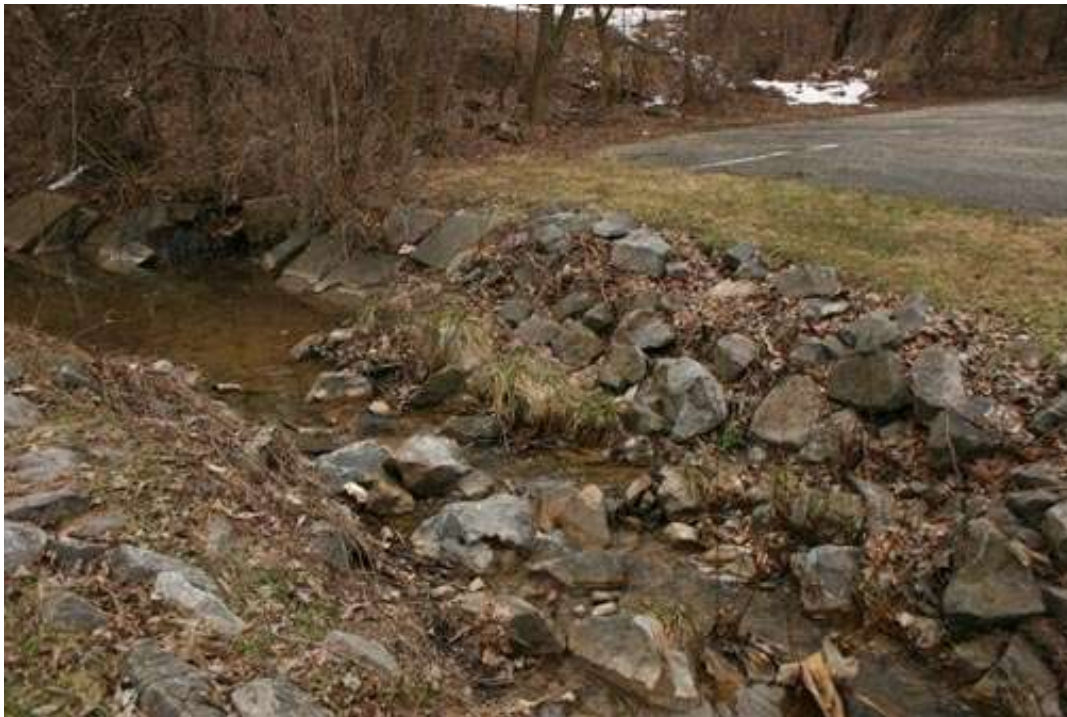
Fig. 2 (view upstream) – Rip-rapped section at upstream end of upstream 66" storm drain outfall.

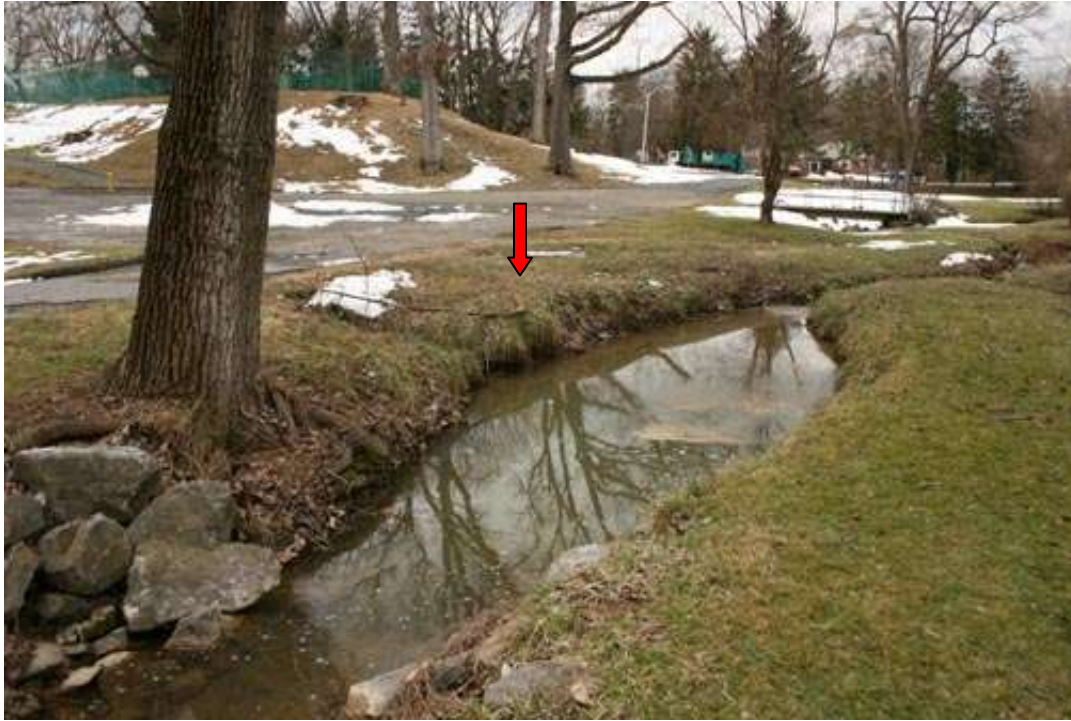
Fig. 3 (view downstream) – Large scour pool at end of rip-rap, 18-inch storm drain out-fall indicated by red arrow.

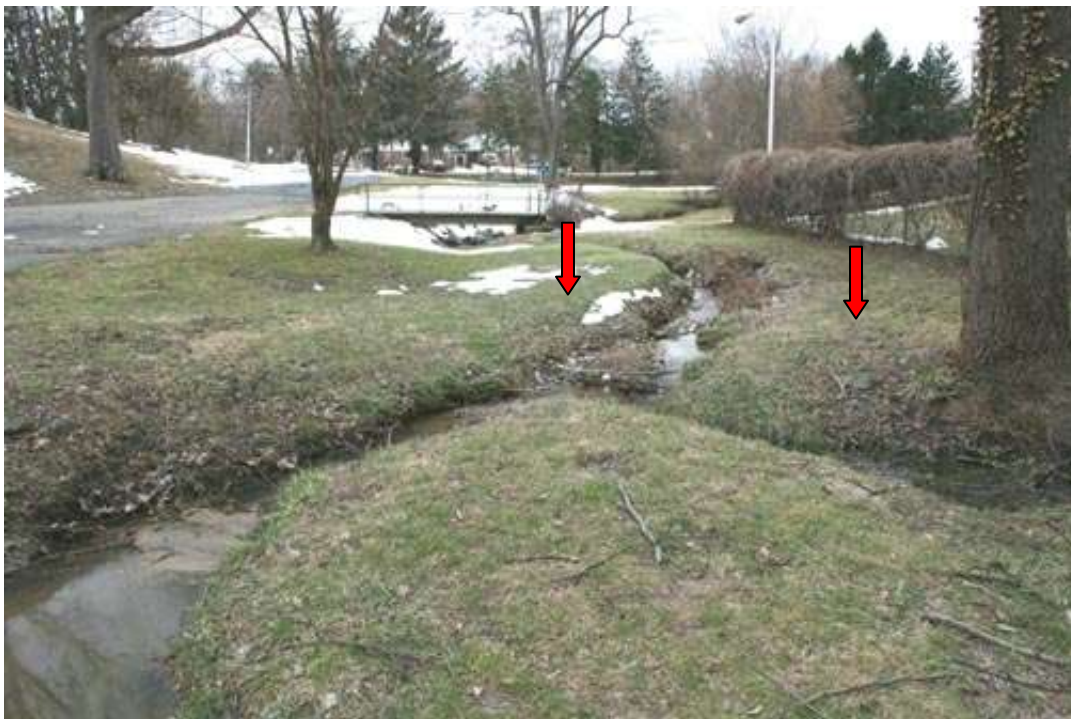
Fig. 4 (view downstream) – Narrow baseflow channel, within bankfull channel (red arrows).

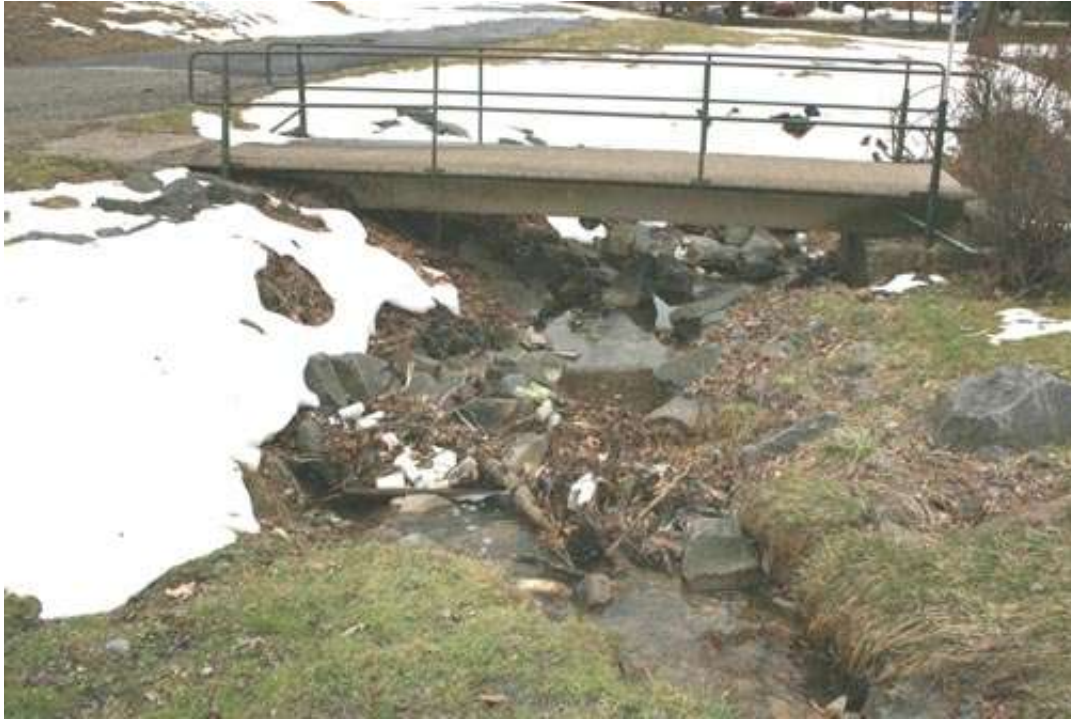
Fig. 5 (view downstream) – Upper footbridge.

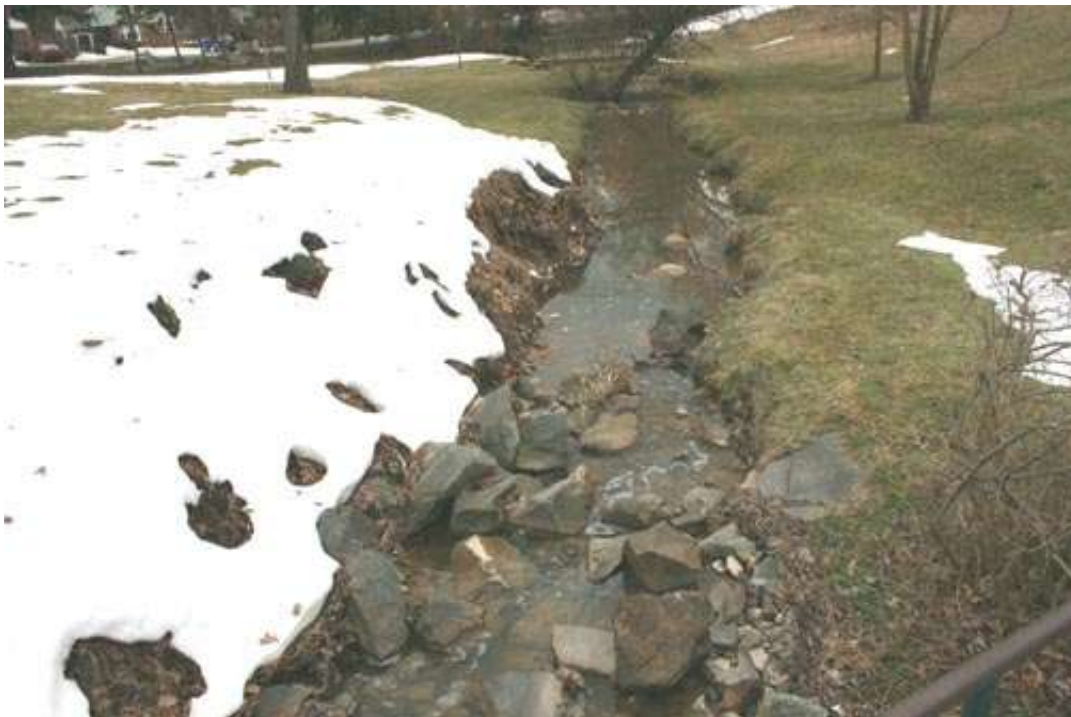
Fig. 6 (view downstream) – Looking downstream from upper footbridge.
Note eroding bank along left side of channel.

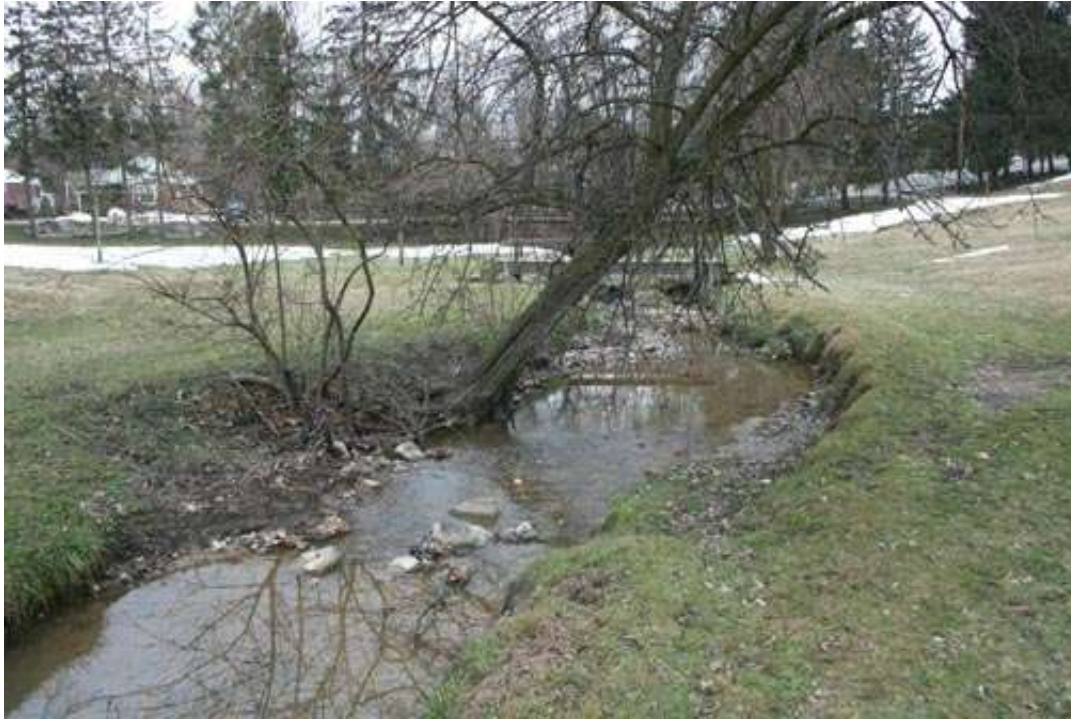
Fig. 7 (view downstream) – Undercut tree (Flowering Apple), bank erosion and sedimentation.

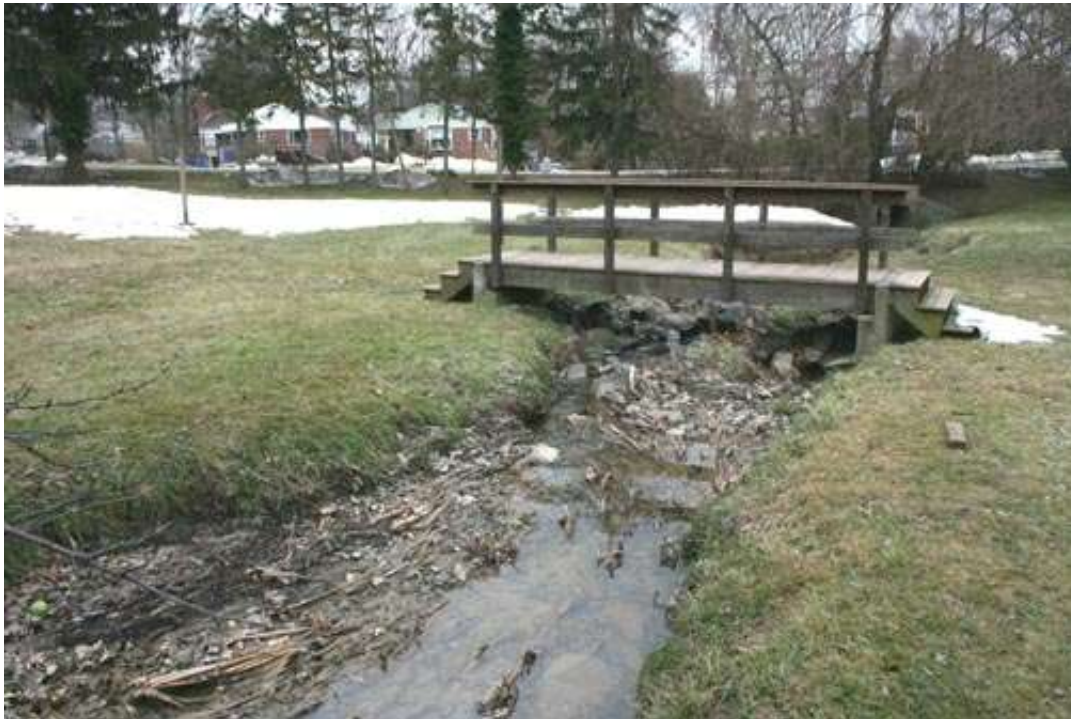
Fig. 8 (view downstream) – Aggradation upstream of lower footbridge.

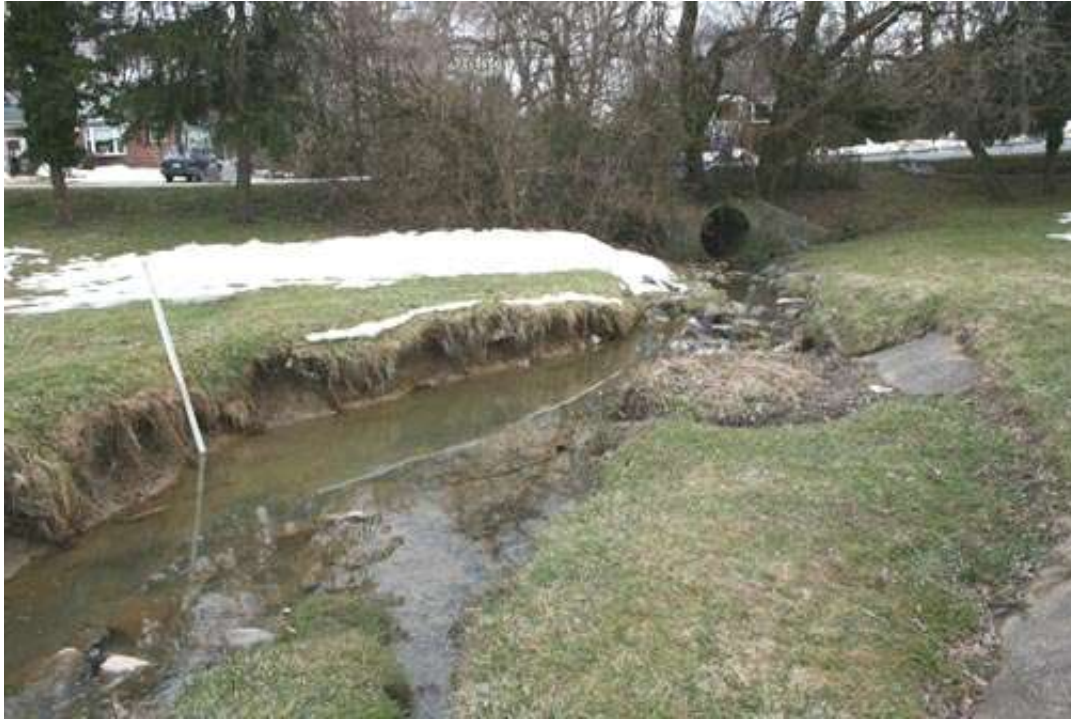
Fig. 9 (view downstream)– Erosion along left bank and concrete revetment visible along right bank.

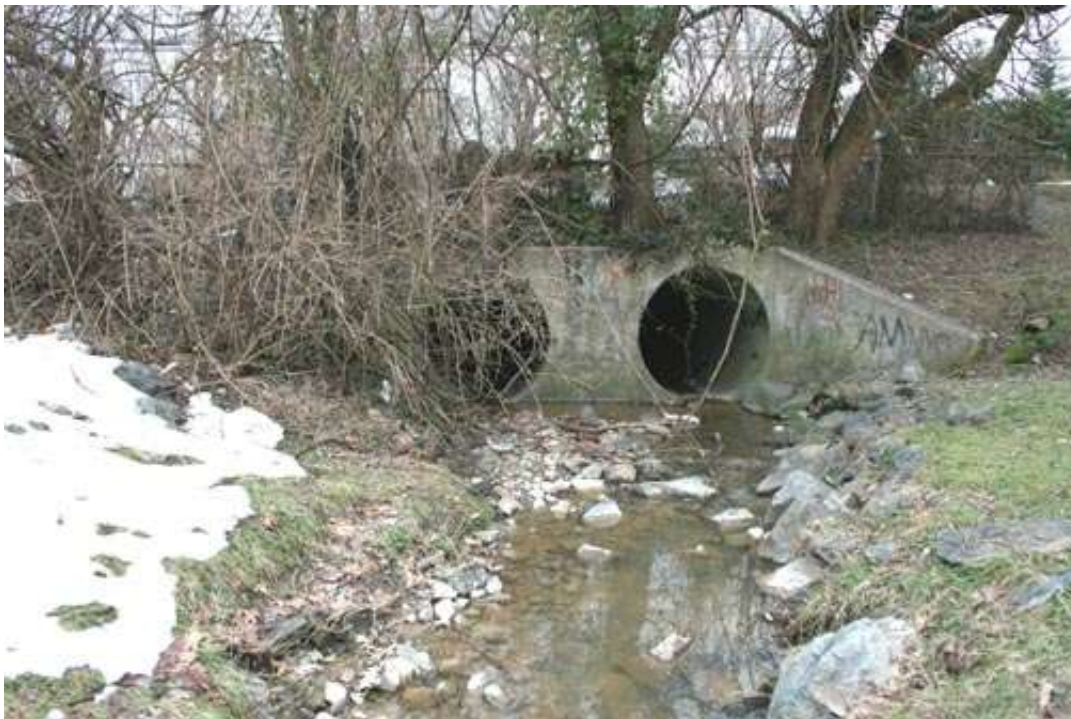
Fig. 10 (view downstream) – Twin 60-inch culvert at Grubb Road.

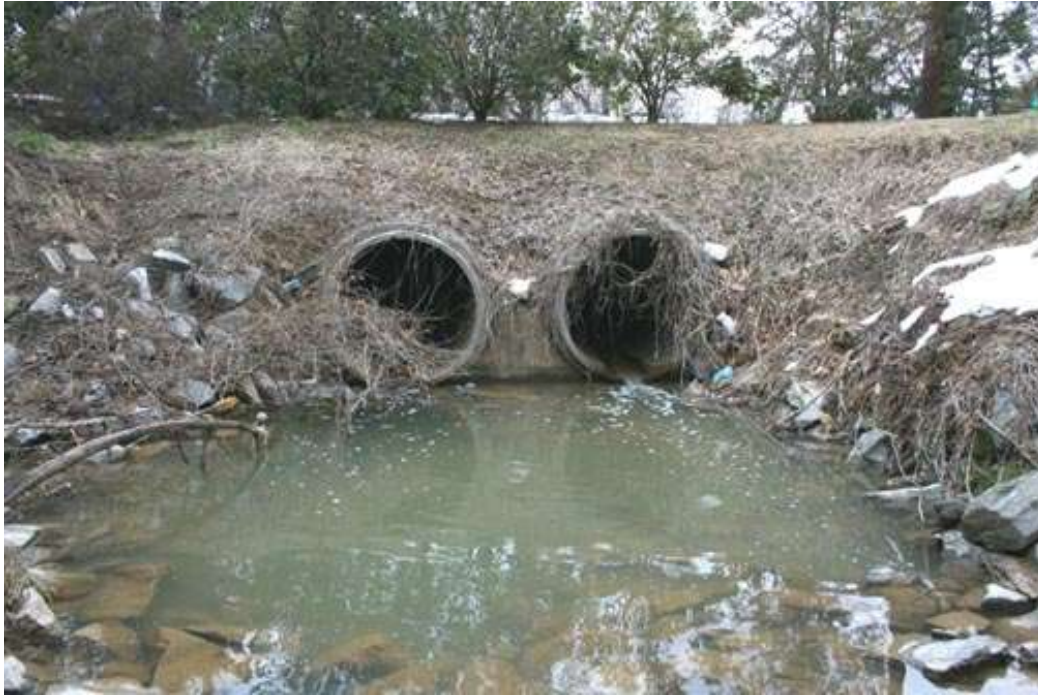
Fig. 11 (view upstream) – Scour pool below culvert at Grubb Road at upstream end of reach.

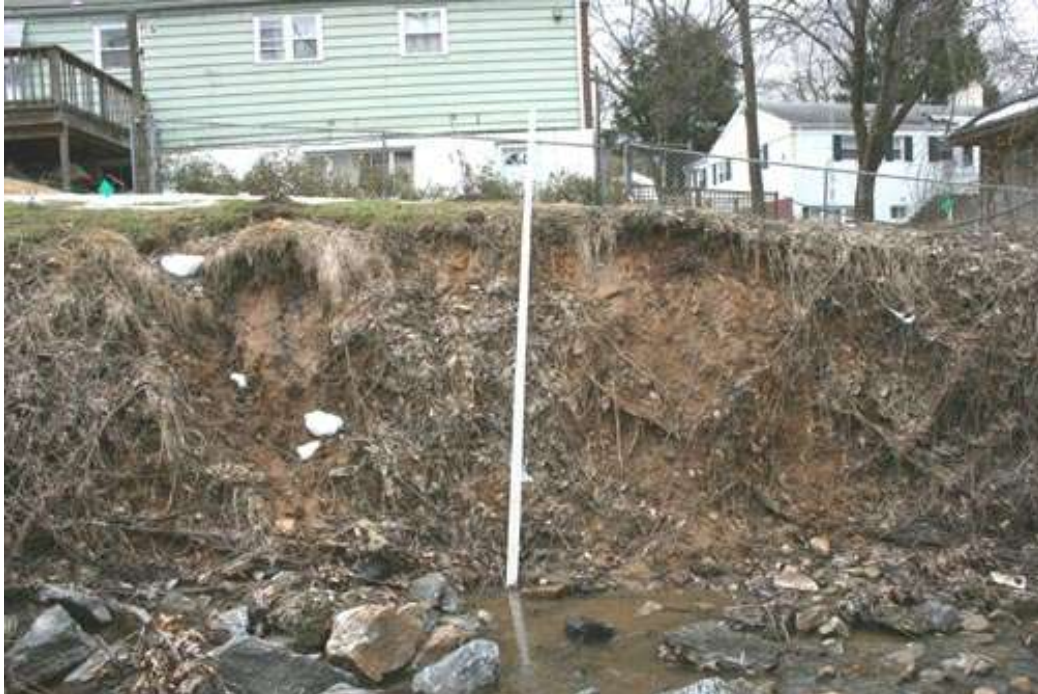
Fig. 12 – Erosion along left bank upstream end of reach.

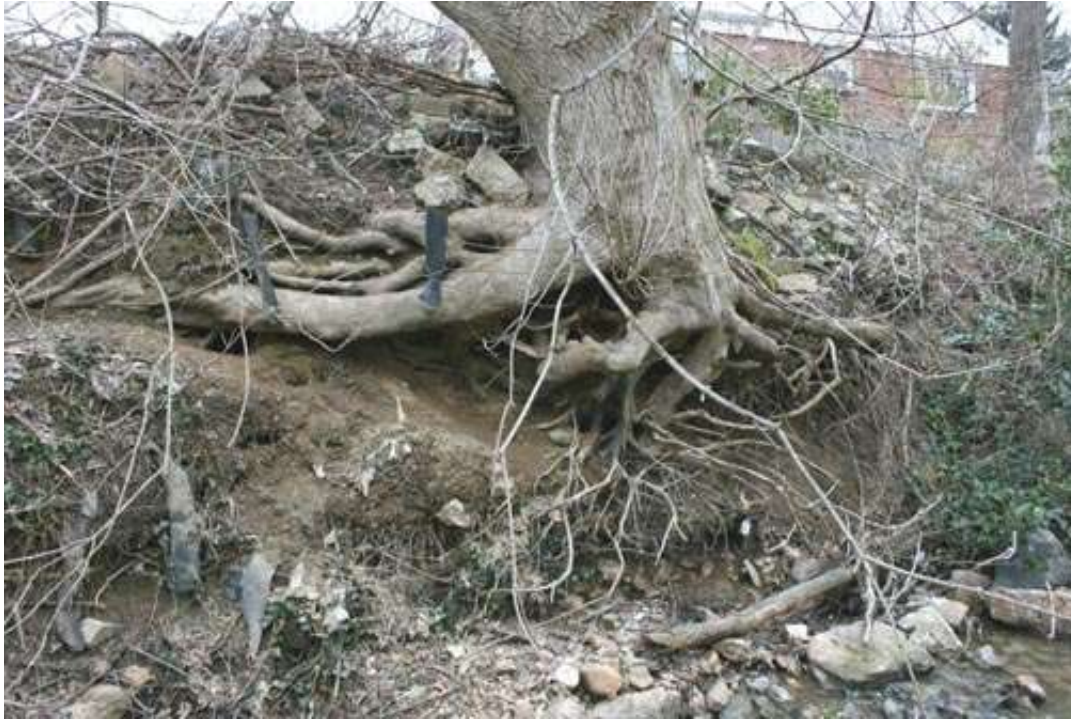
Fig. 13 – Severely undercut tree (Red Oak) along right bank. Landowner has placed rip-rap in an attempt to stabilize the slope above the tree.

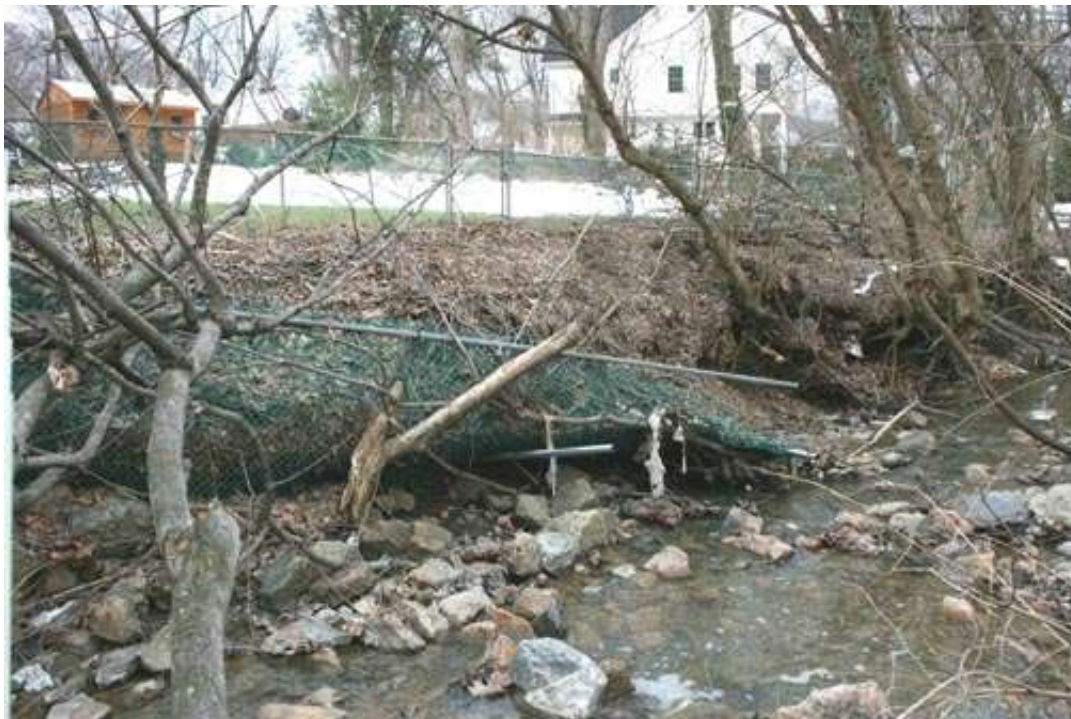
Fig. 14 (view downstream) – Failing left bank has undermined fence causing it to collapse into channel.

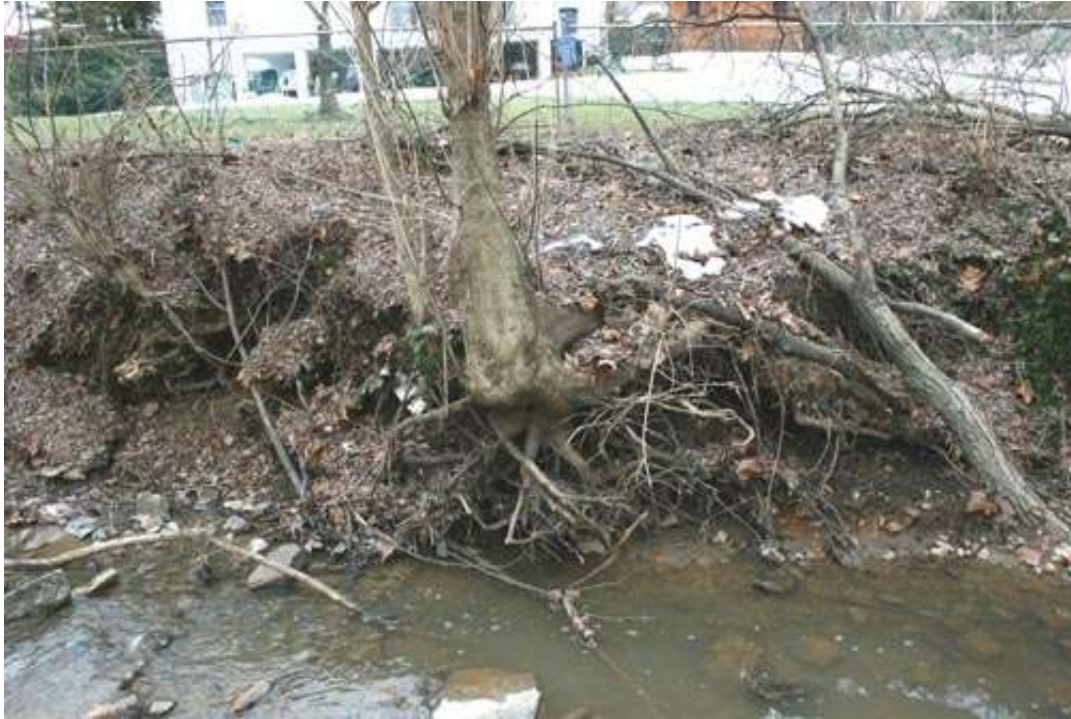
Fig. 15 – Severely undercut tree along left bank. Yard waste evident along bank.

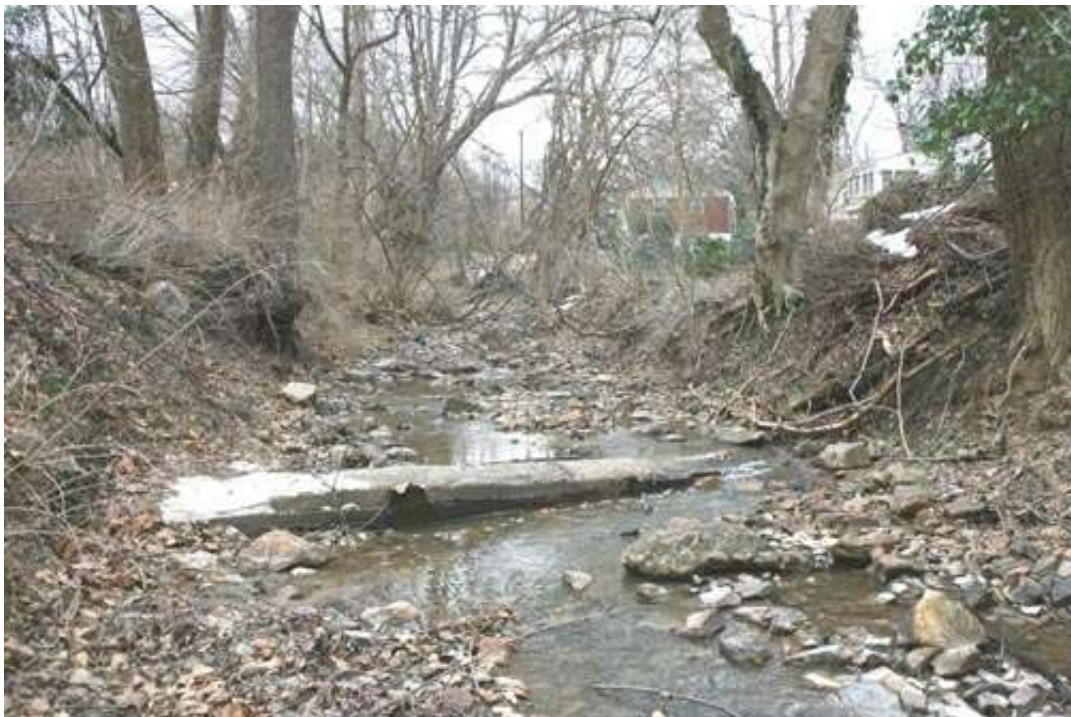
Fig. 16 (view downstream) – Exposed sanitary sewer line with concrete encasement.

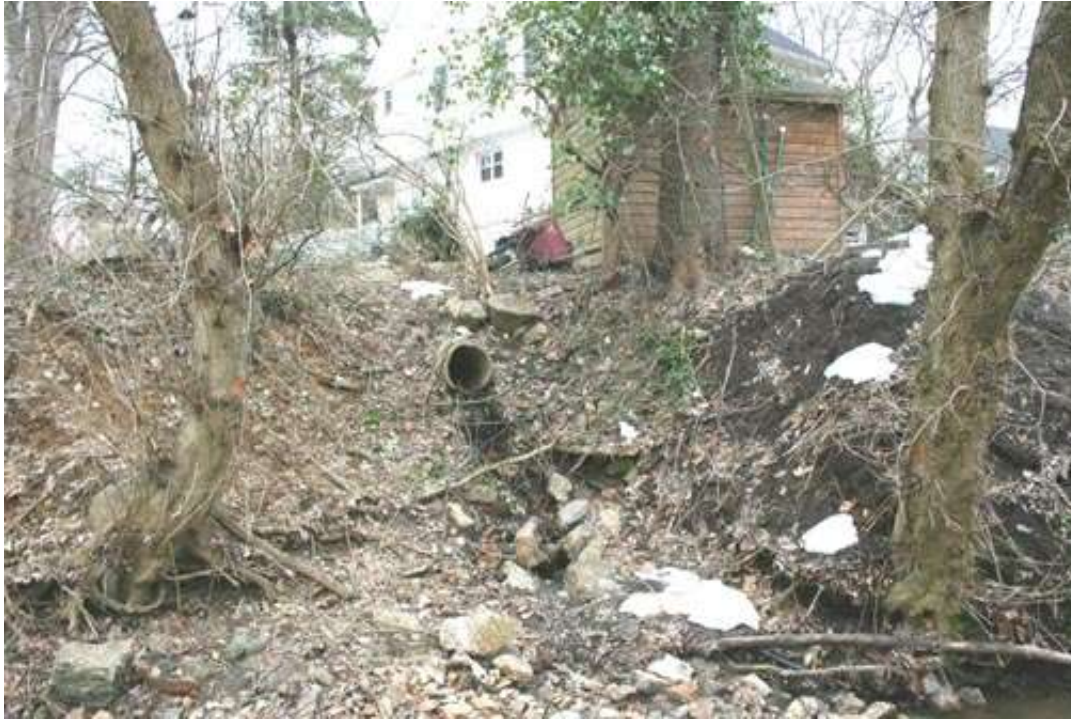
Fig. 17 – 15" RCP storm drain outfall at end of Navarre Drive on left bank.

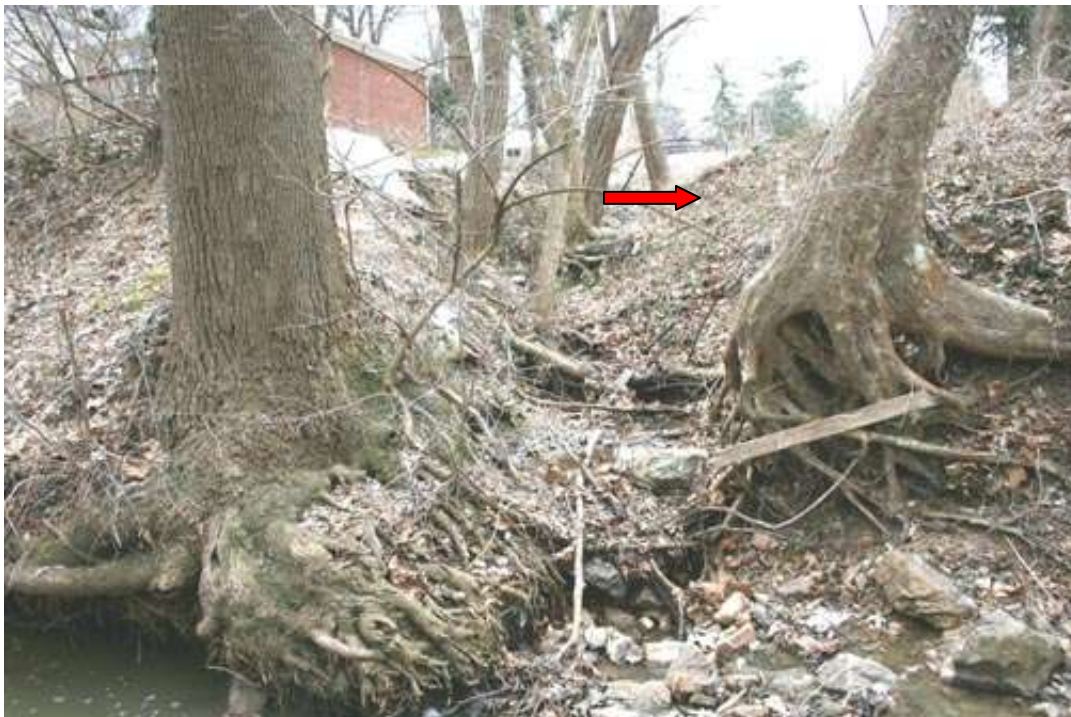
Fig. 18 – Gully conveying runoff from 15" RCP storm drain outfall (as shown by arrow) at end of Navarre Drive on right bank.

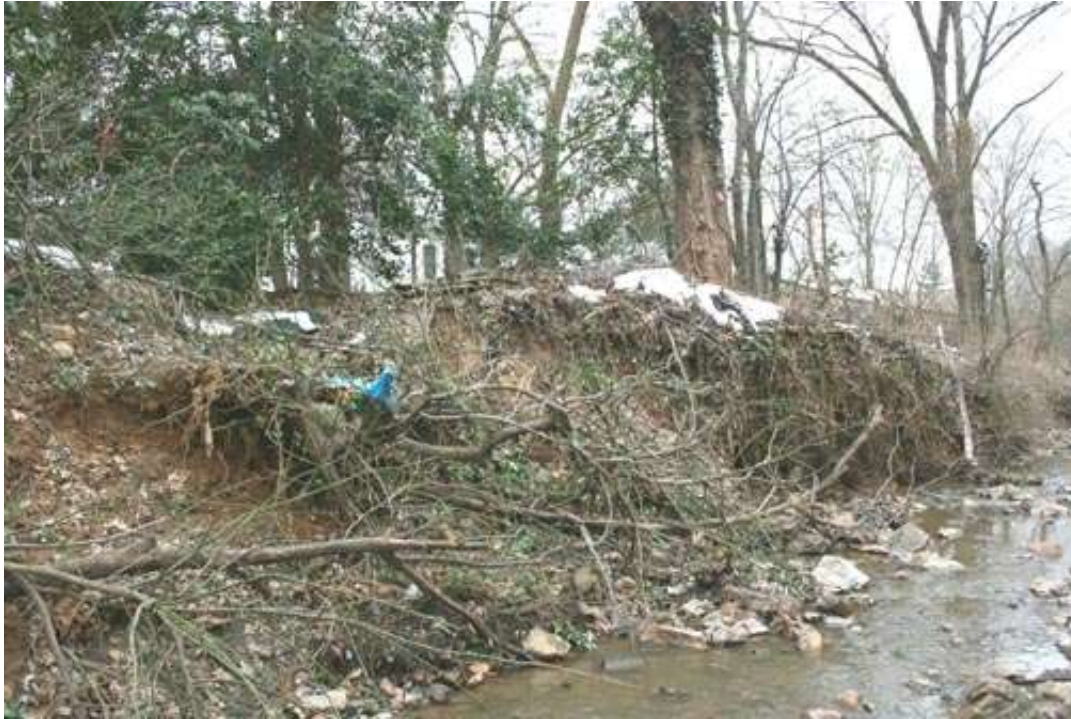
Fig. 19 (view downstream) – Erosion along left bank with undercut tree (Red Maple) in background.

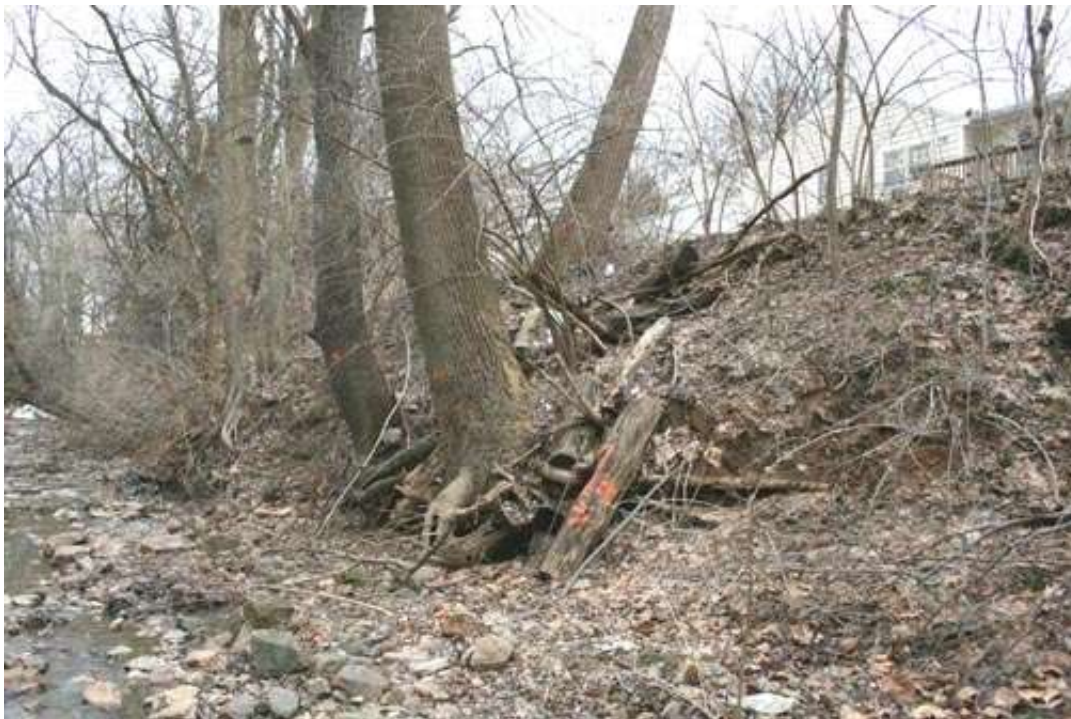
Fig. 20 (view downstream) – Failing slope on right bank with undercut falling trees.

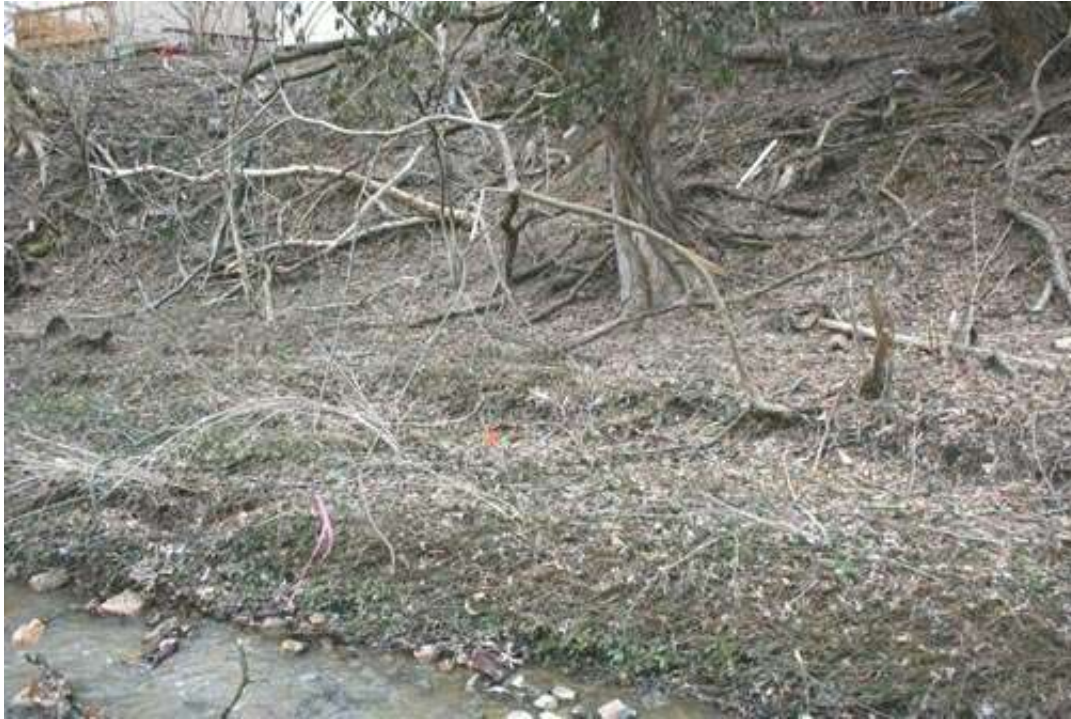
Fig. 21 (view downstream) – Well defined bankfull bench on right bank in B4c section of reach.

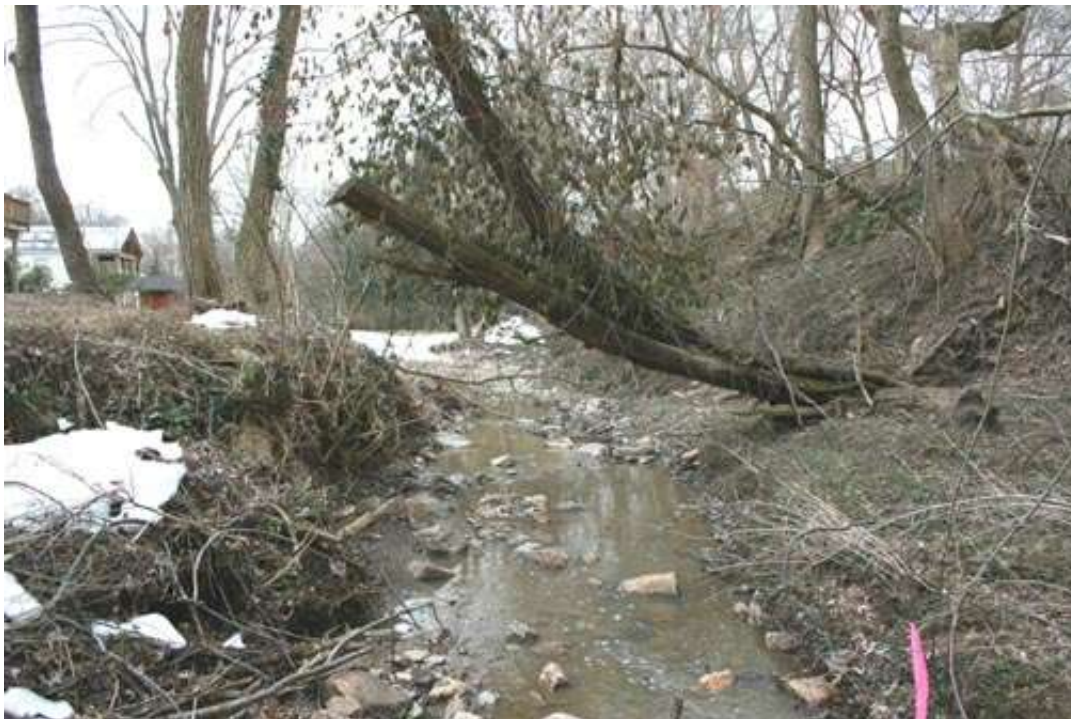
Fig. 22 (view downstream) – Eroding left bank and leaning tree along right bank.

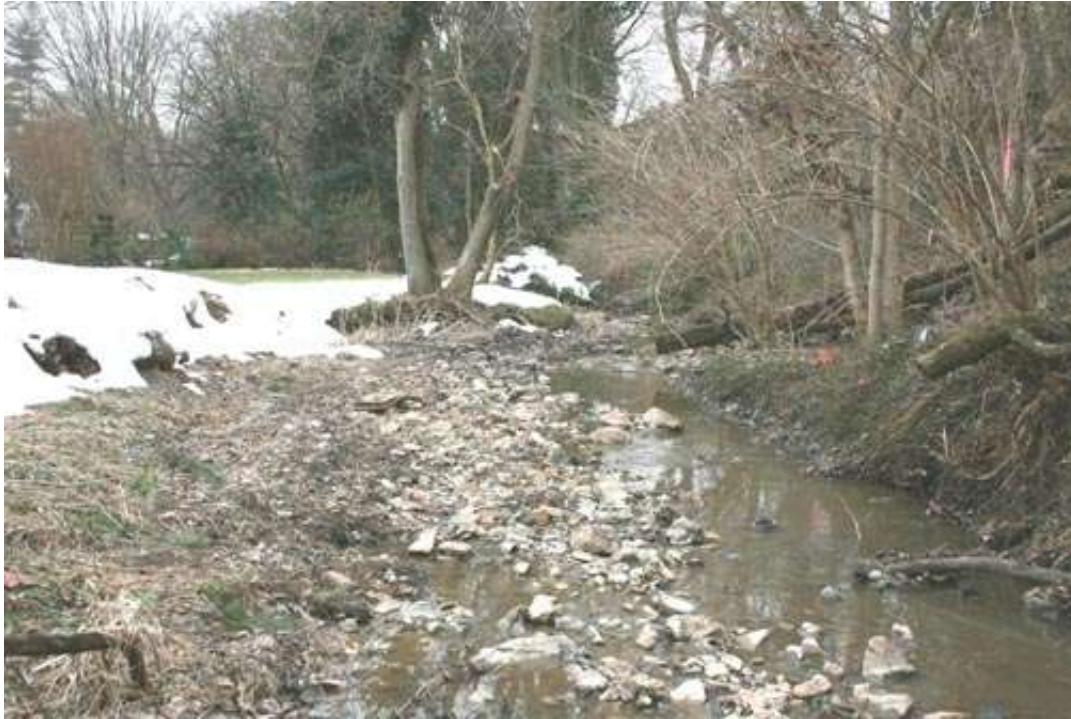
Fig. 23 (view downstream) – Bankfull bench and lateral bar developing adjacent to eroding left bank.

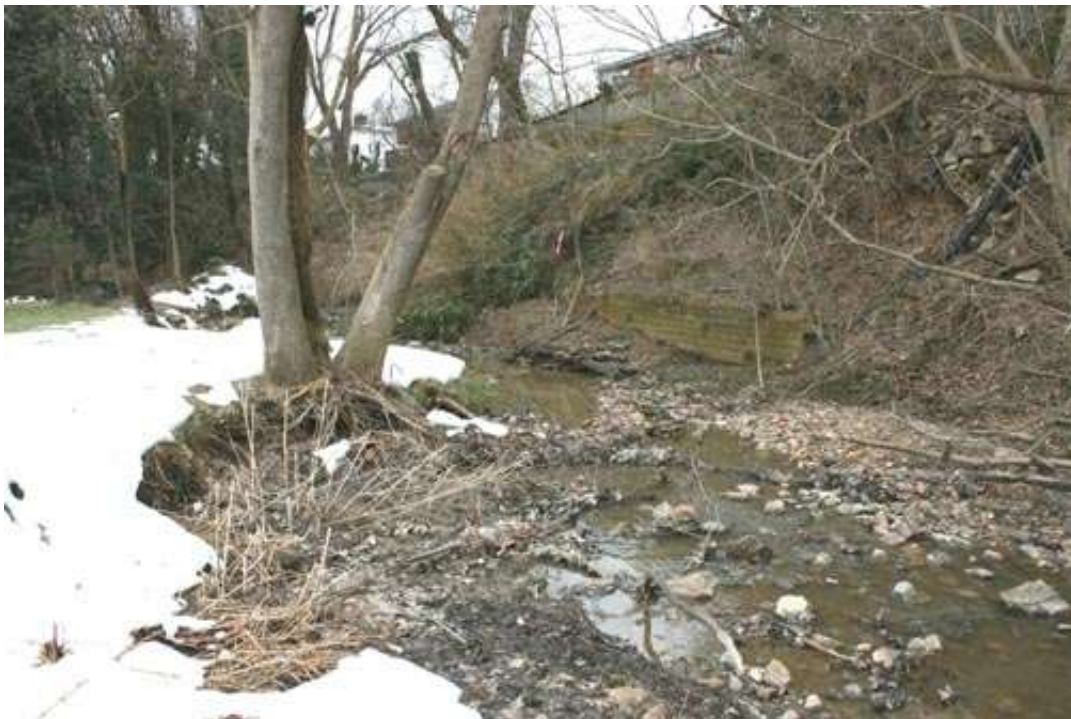
Fig. 24 (view downstream) – Undercut trees (Green Ash) on left bank and lateral bars along both sides of channel.

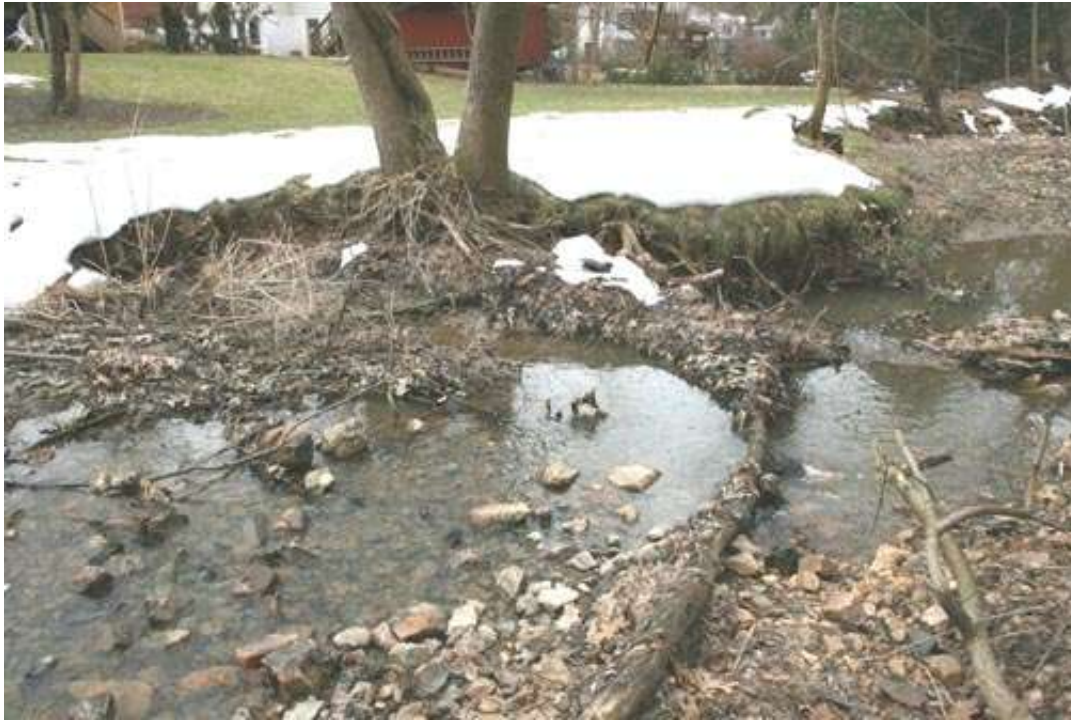
Fig. 25 (view towards left bank)– Debris jam and aggradation in middle section of reach.

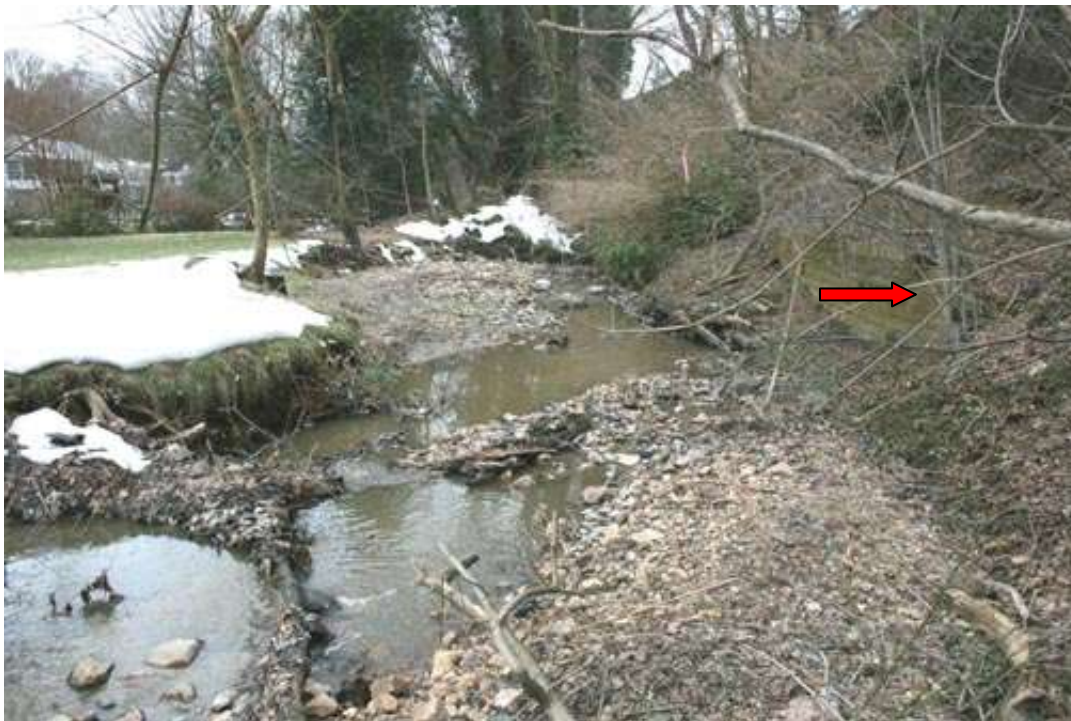
Fig. 26 (view downstream) – Large lateral bars along middle section of reach, with timber retaining wall supporting toe of high terrace on right bank (red arrow).

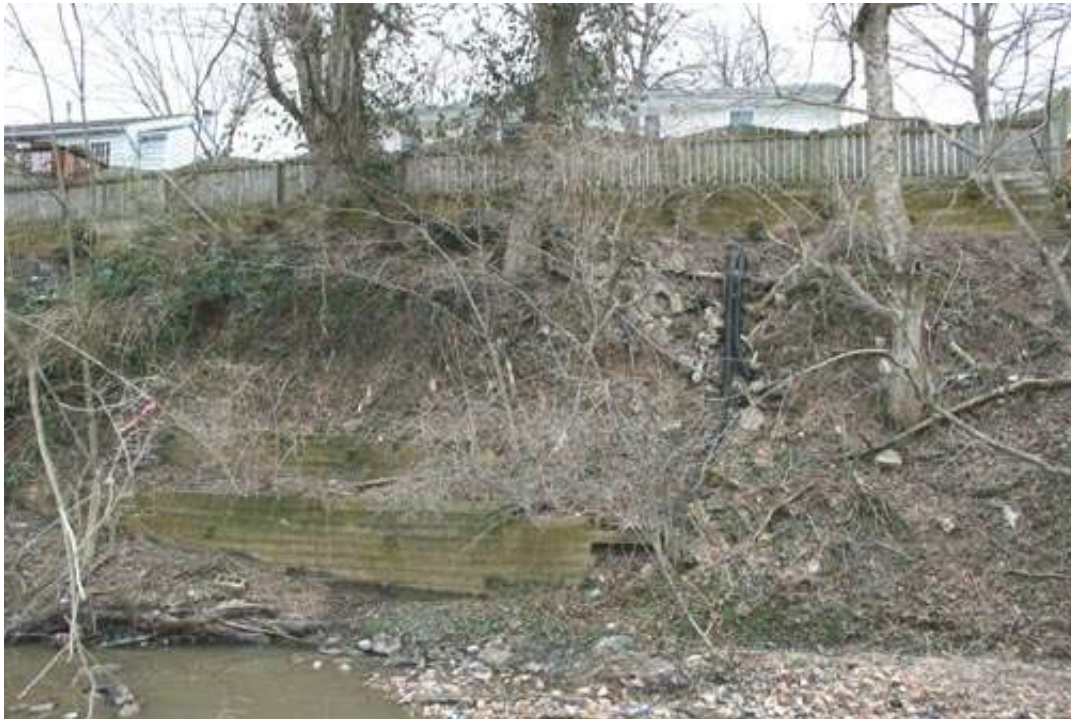
Fig. 27 (view towards right bank) – Slope on right bank with timber retaining wall, drain tile, and rip-rap.

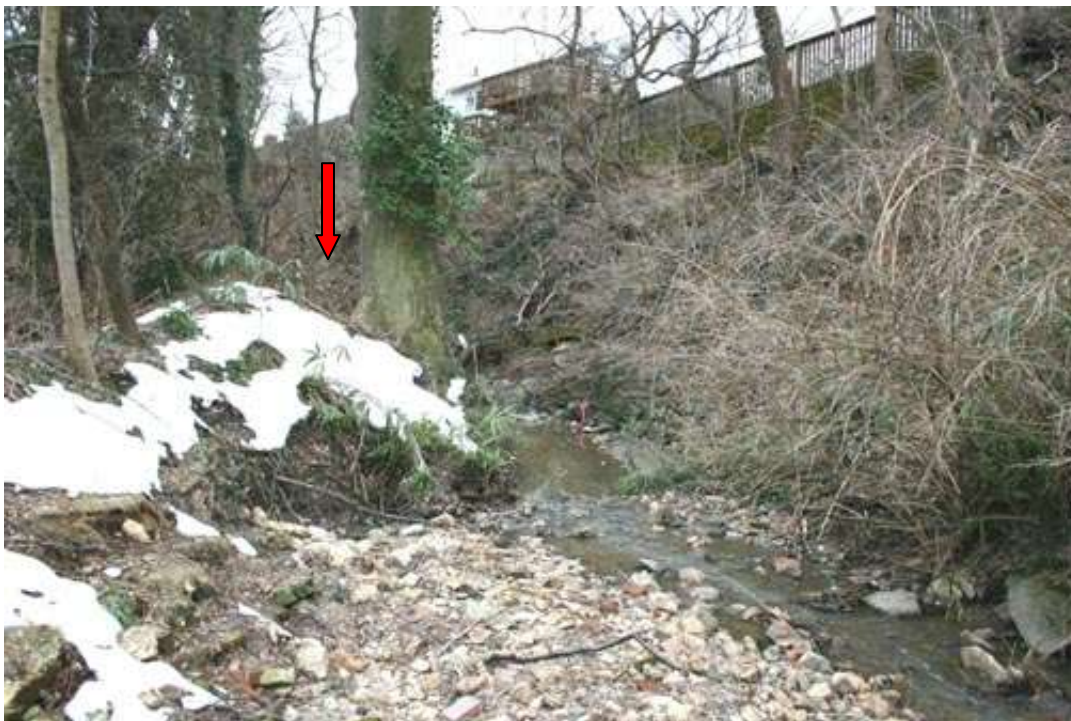
Fig. 28 (view downstream) – Constriction in lower section of reach, large tree (Green Ash) on flood berm (red arrow).

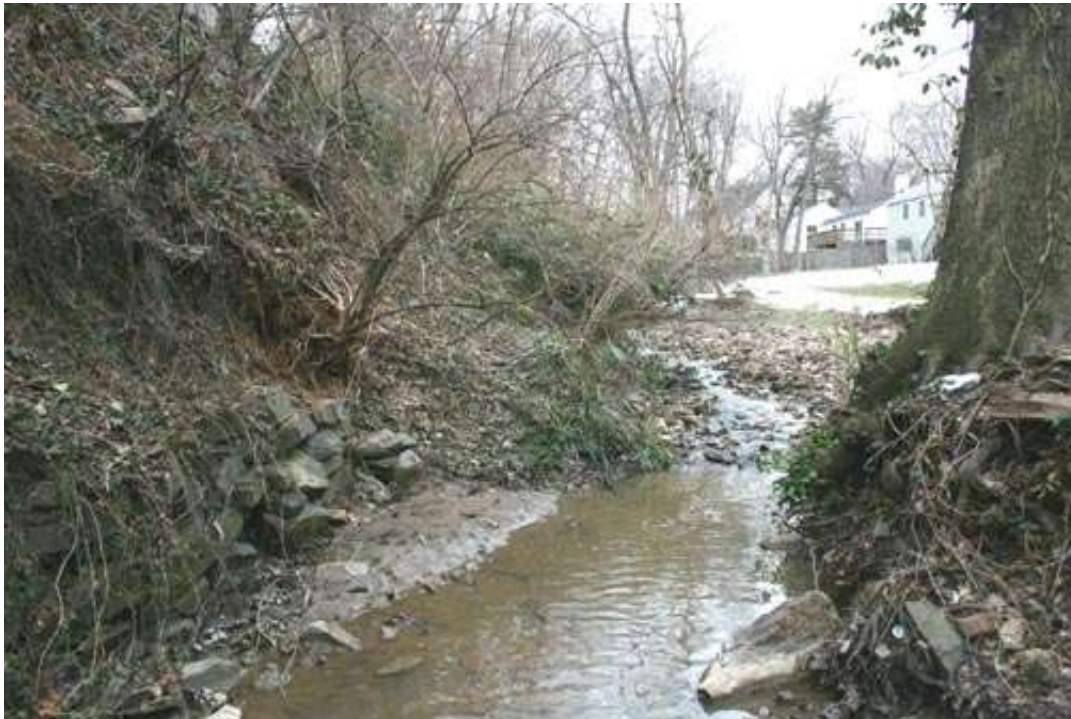
Fig. 29 (view upstream) – Constriction in lower section of reach stacked rock retaining wall to left of photo and large tree (Green Ash) on flood berm to the right of photo.
